OV-1

# ACCIDENT SUMMARY

MAJORS • MINORS • INCIDENTS • FORCED LANDINGS

NOVEMBER 1, 1961 TO OCTOBER 31, 1963

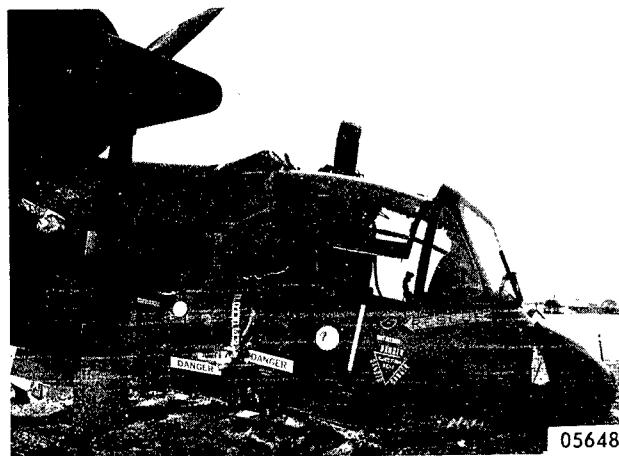
06672

THE ACCIDENT: Explosion occurred next to

fuselage in vicinity of flare pod when remaining flares were salvoed in completion of night photo mission. Fuselage broke in two and aircraft crashed. Pilot ejected and sustained minor injuries. Copilot failed to eject and sustained fatal injuries.

**THE CAUSE:** The most probable cause of this accident was premature firing of one or more flares which caused an explosion in the flare pod.

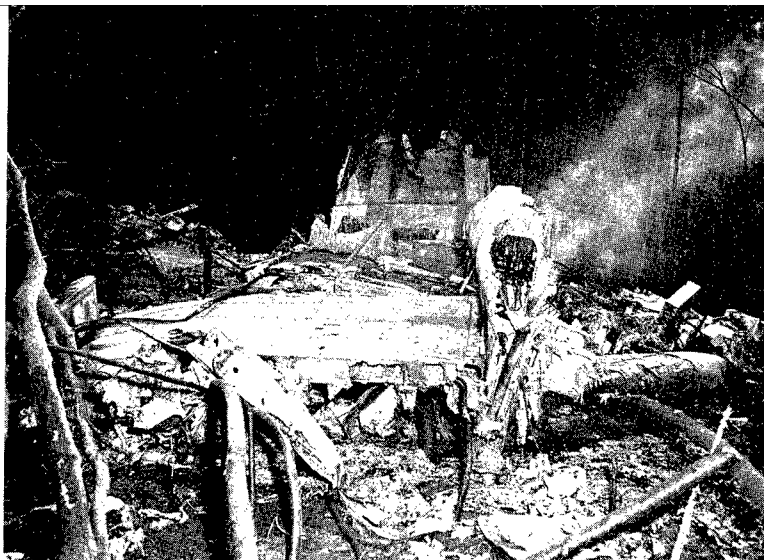
06847

**THE ACCIDENT:** Nr. 2 engine failed in flight. Propeller was feathered. Pilot was unable to jettison auxiliary fuel tanks electrically and elected not to attempt manual jettison. Aircraft lost altitude and

airspeed en route to airfield. Pilot and passenger ejected at approximately 150 feet. Aircraft crashed and burned. Pilot sustained compression fractures of vertebrae and abrasions. Passenger sustained compression fractures of vertebrae, second degree burns on hand, minimal burns of face, and abrasions. Burns caused by descent through flames of burning aircraft.

THE CAUSE: Engine failed (cause undetermined); auxiliary fuel tanks failed to jettison by electrical means (cause undetermined); and pilot failed to manually jettison auxiliary fuel tanks (emergency procedure outlined in -10).

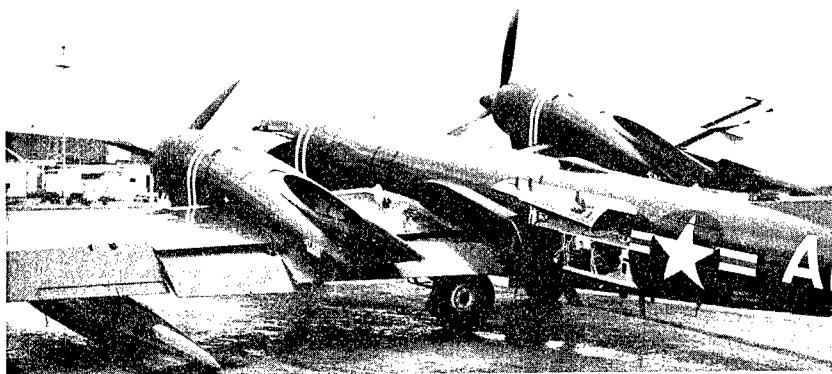
05430

THE ACCIDENT: Nose wheel struck loose rocks,

causing blowout of nose wheel tire as propellers were reversed during strip landing. Nose gear collapsed. Major damage to wing, center section, fuselage, landing gear, flaps, propellers, and engine.

THE CAUSE: Presence of loose rocks on runway.
